# LITTLEVILLE

## DAM & RESERVOIR

MIDDLE BRANCH, WESTFIELD RIVER, MASSACHUSETTS

#### SITE GEOLOGY

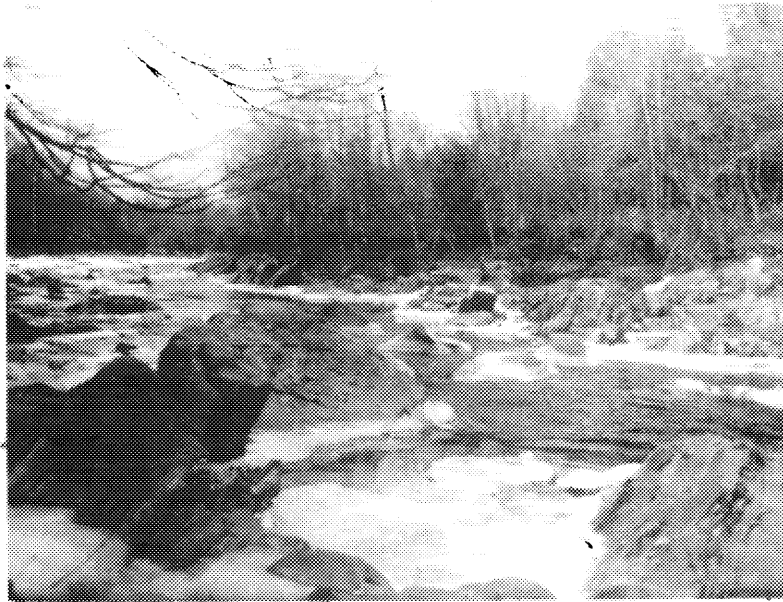
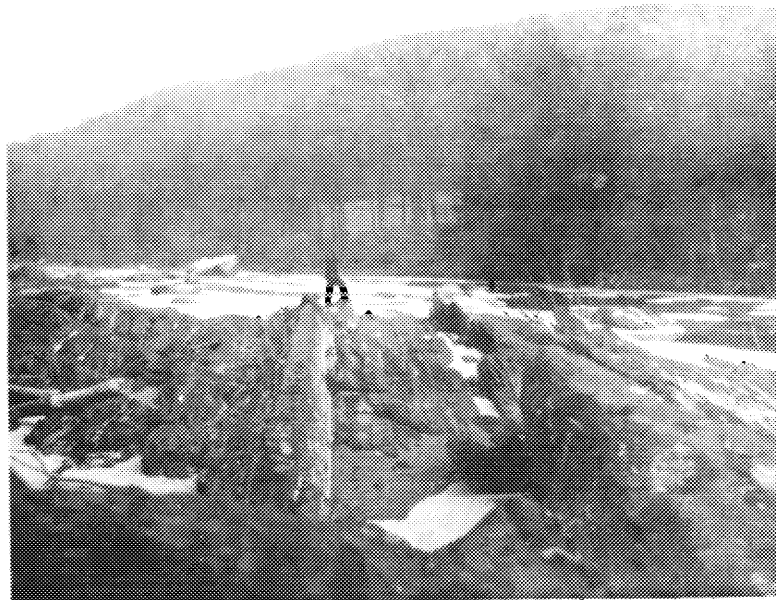
TYPICAL BEDROCK EXPOSED IN RIVER CHANNEL

LITTLEVILLE DAM SITE

a. Bedrock throughout the entire site as observed at the extensive areas of exposed bedrock in the stream channel and on the left abutment, and as shown by the rock cores, consists of a series of thin-bedded, steeply dipping mica schists with occasional thin beds of
